**FEDERAL AVIATION ADMINISTRATION
AIRWORTHINESS DIRECTIVES
LARGE AIRCRAFT**

BIWEEKLY 2000-11

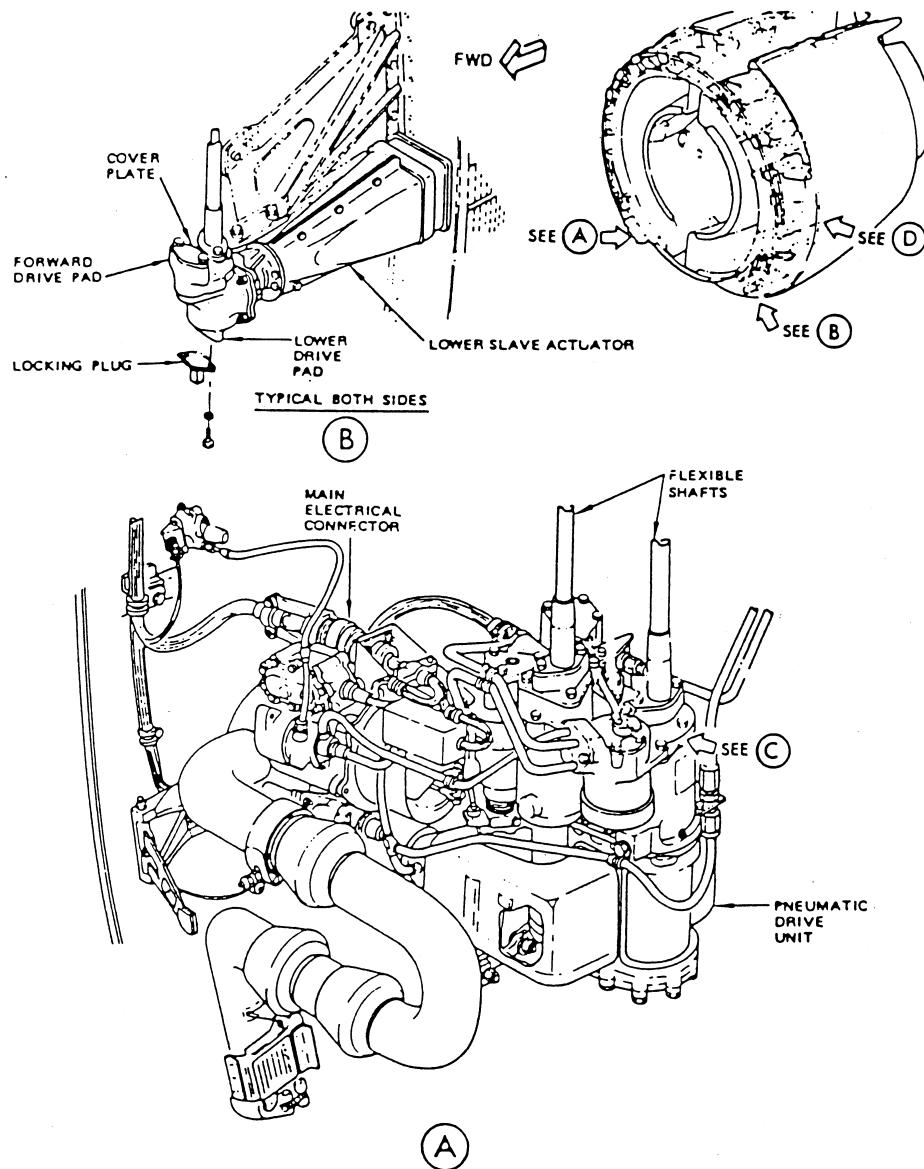
Figure 1

- (9) If sleeves move, replace the right-hand sync-lock.
- (10) Move left-hand sync-lock lever to the locked position.
- (11) Move right-hand sync-lock lever to the unlocked position.
- (12) Repeat step (8) above.
- (13) If sleeves move, replace the left-hand sync-lock.
- (14) Move left-hand sync-lock lever to the unlocked position.
- (15) Rotate actuator gearshaft to fully stow the sleeves.
- (16) When translating sleeves reach stowed position, check that stow latch hooks have engaged fixed hooks on both sides (detail D).
- (17) Depress latch operating arm and disengage latch arm (detail C); allow latch arm to raise.
- (18) After releasing arm, verify latch engagement by attempting to rotate feedback gear on drive unit using 1/4-inch square drive; gear shall not rotate in excess of 0.1 of a turn.

- (19) As applicable, install locking plug (with square section facing away from drive pad) or coverplate on actuator drive pad. Secure plug or plate with bolts tightened to 50-70 pound-inches.
- (20) Move both left- and right-hand sync-lock levers to the locked position.
- (21) Close fan cowl doors (Ref 71-11-02, Maintenance Practices).
- (22) Close T/R CONT & BLEED SYS circuit breaker.
- (23) Repeat the sync-lock integrity test on all remaining thrust reversers.
